Battery Failure on the Electric Propulsion Space Experiment (ESEX)

**Air Force Research Laboratory (AFMC)
AFRL/PRSS
5 Pollux Drive
Edwards AFB, CA 93524-7048**

November 2001

Special Report

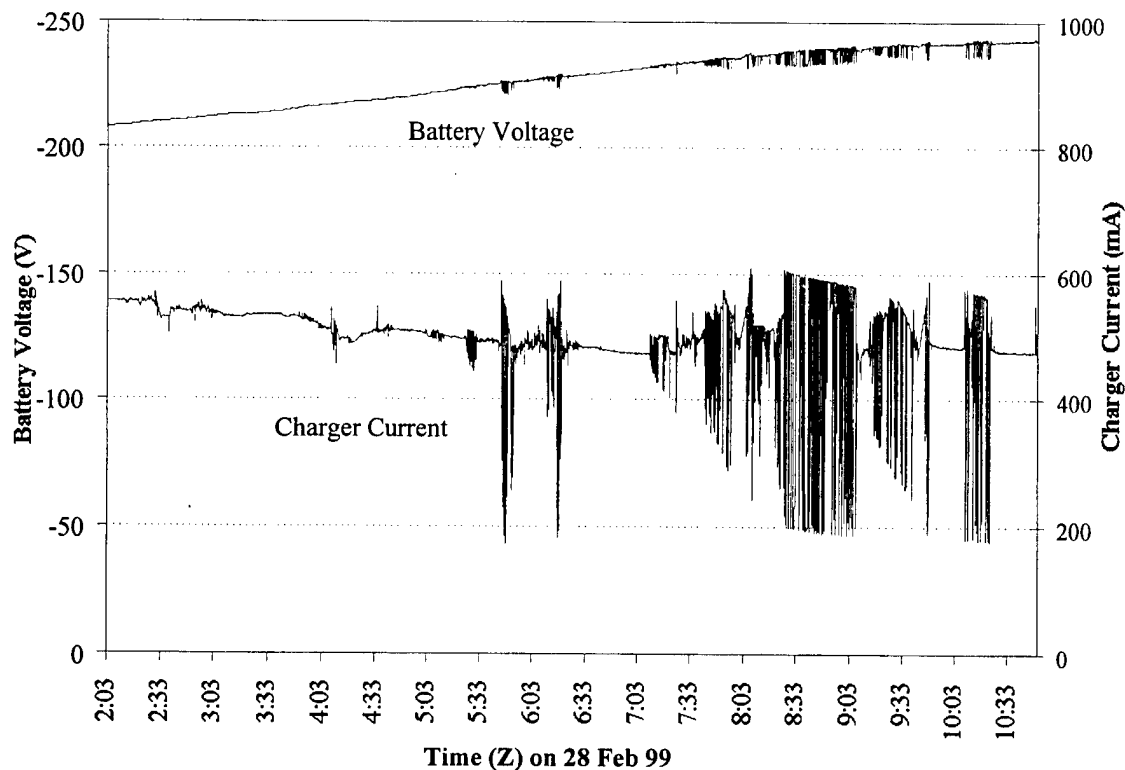
Figure 3. Typical Battery Charging Circuit Instability

The first signs of anomalous behavior in the battery were observed during the first charging cycle, which was initiated approximately 60 hours after launch.¹³ As indicated above, the charger was designed to provide an output current of 0.67 A to the battery. Within nine hours of

turn-on, however, the charger output was less than 0.6 A, and decreasing. Although the charging circuit was operating at this lower output current, the charging proceeded nominally and was continued while the data was being monitored. As charging progressed over the next 48 hours, the output current remained stable around 0.57 A until the battery voltage approached -225 Vdc. At this point, as shown in Figure 3, the output current from the charging circuit began cycling on and off, resulting in oscillations of the open circuit battery voltage, charger output current, and even on the ARGOS 28 Vdc main bus current and voltage (not shown here). Initially, this was thought to be a result of higher-than-expected internal battery impedance as the charging progressed and the battery cooled – exacerbated by a low rate of charge. As the battery impedance is increased, the current loop control circuit in the battery charger becomes unstable, and results in the charger cycling on and off. This impedance was determined by taking the ratio of the change in battery voltage to the change in battery charge current. Near the first charging cycle, this impedance was calculated to be approximately $13\ \Omega$ – lending further credence to this proposed source of charging instability.

In an attempt to offset this problem and lower the effective charging circuit impedance, high capacitance filters were switched into the circuit via high voltage relays connecting the battery with the PCU.¹² This increased capacitance improved the charger performance, but did not eliminate the fluctuations. Since the output current instability was not detrimental to the ESEX battery or the spacecraft bus, charging was performed through this region. The total charging time was then increased to compensate for the charging inefficiencies resulting from the cycling output from the charger.

During the subsequent charging cycles, further degradation was observed as the battery impedance appeared to increase to a point where the charger would shut off prior to attaining a full state of charge. When attempting to restart charging at a battery voltage above -225 Vdc, for instance, the battery voltage would spike up to the software or hardware limit, and immediately shut off. The impedance required to cause this behavior was calculated in the same way to be approximately 58 Ω . When the battery voltage was allowed to discharge to below -220 Vdc, however, the charger successfully turned on and continued to charge to near the -247 Vdc turnoff point. Subsequent analyses indicate these instabilities might have actually been symptomatic of the ultimate problem, and may not have improved with either a more robust charger circuit design, or a higher output current.

The ESEX failure suggests an electrolyte expulsion problem as was concluded in the write-up. In Figure 3, the first indications of problems are evident. Between 5:33 and 6:03 Z, the battery voltage is seen to drop about 6.0 volts. The granularity of the data appears to be too coarse to be able to see a short circuit within a single cell. The 6-volt drop suggests a short circuit to ground. In addition, there could have been a short circuit within a cell that actually melted the cell case allowing electrolyte to leak out and form a shorting path to the grounded battery box. That is, the electrolyte path could come from a hole melted in the cell case or from electrolyte being expelled out through the cell vent. Since a hole in the cell case resulted in the failure of the ESEX battery several years ago, this same problem may have initiated the short to the battery box in the flight battery. In Figure 5, the short to ground has grown to a much more significant short circuit. Silver-zinc cells have the capability of extremely high rates of internal discharge during a short circuit inside a cell. They have been known to catch fire during these events. The cell cases are made from combustible plastic materials. At the elevated temperatures of a fire, the silver oxide material will disassociate liberating oxygen that will encourage the fire. All of this thermal energy can produce steam as the electrolyte is heated above its boiling point.

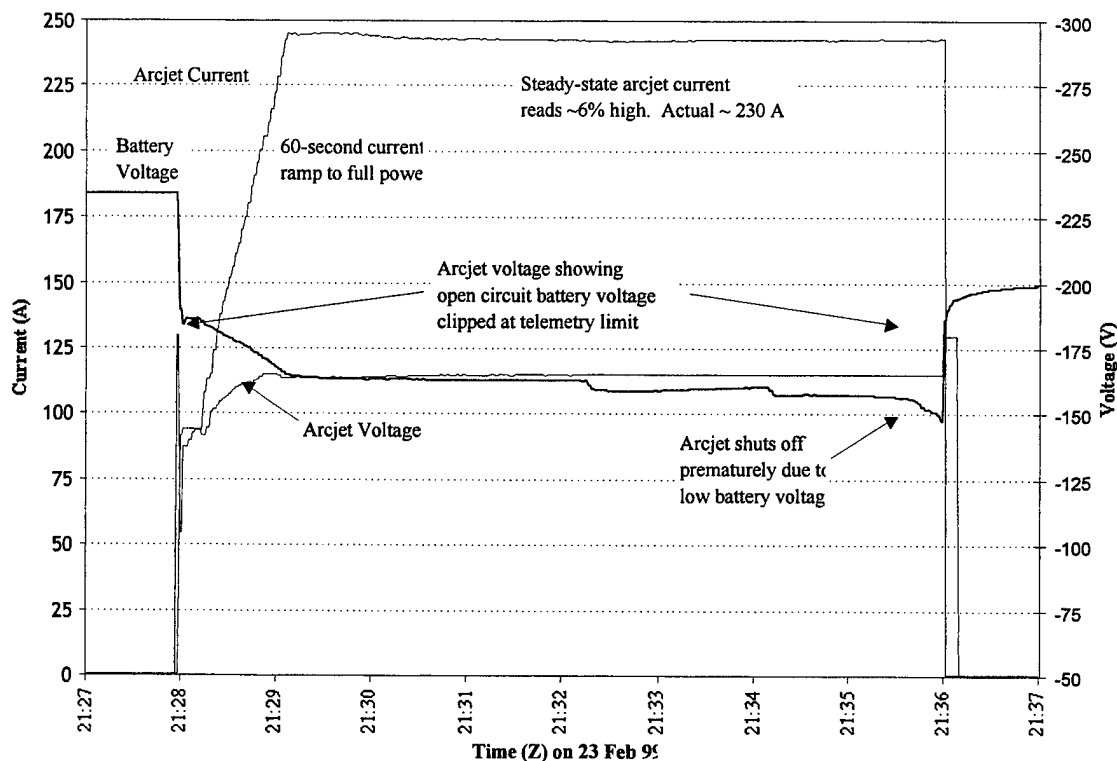
Figure 4. Example of a Premature Arcjet Firing Shut-off as a Result of the Low Battery Output Voltage. Data is Taken from Firing #4.

Beginning on firing #4, however, a decrease in the battery output voltage was observed that limited the total firing duration. As shown in Figure 4, this drop in output voltage resulted in

unstable PCU and arcjet operation, and eventually extinguished the thruster. The duration of each firing from #4 through #8 steadily decreased from 482 seconds to 42 seconds, as the battery performance deteriorated. After firing #7, an attempt to recondition the battery was made by performing a deep discharge through the existing bleed resistors, and restarting the charge. The initial plan was to wait until the battery was at a full state of charge (indicated by the charger circuit shutting off at the upper voltage limit) before attempting the next firing. After more than 19 days, however, the charger was commanded off and a firing was attempted. As indicated above, the duration of firing #8 showed the reconditioning did not have the desired effect.

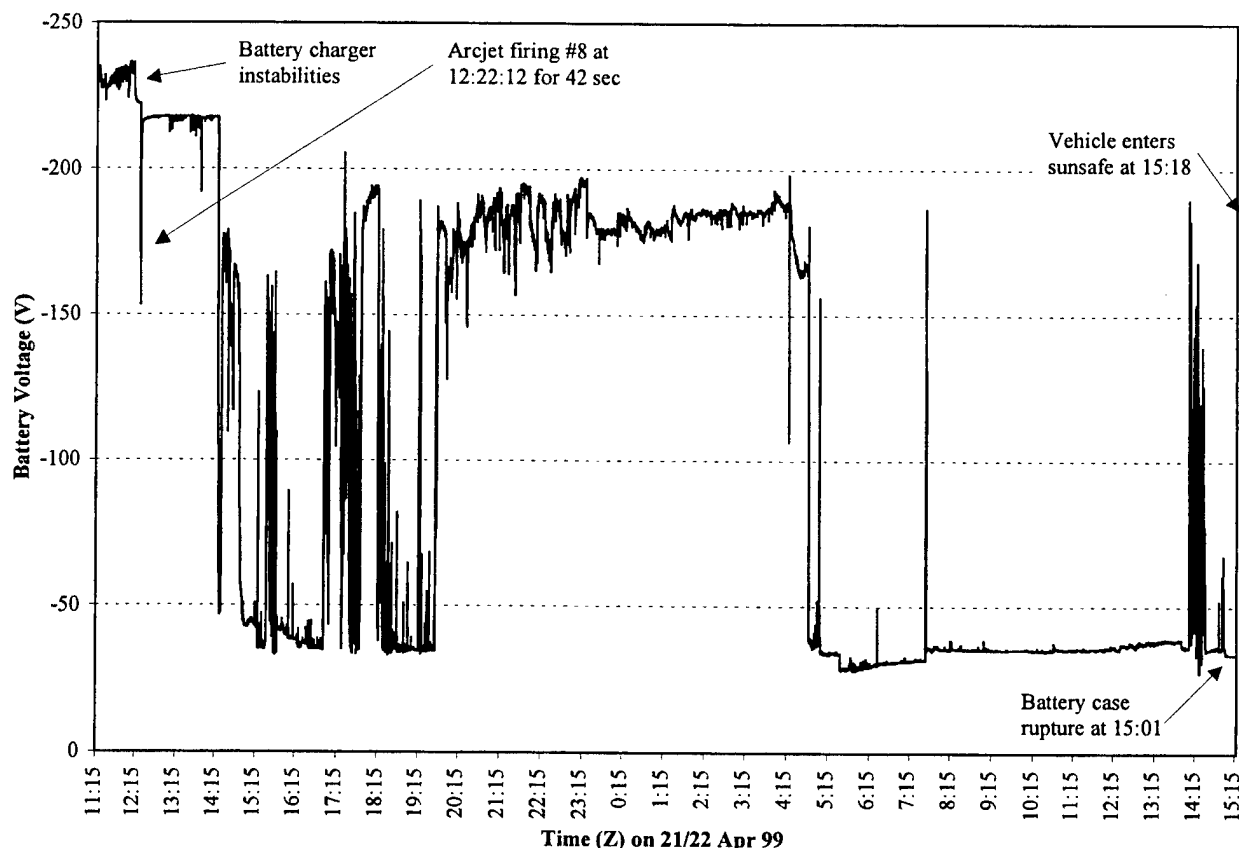
Figure 5. Battery Voltage Fluctuations Following the Final Arcjet Firing (#8) Ultimately Resulting in the Short Circuit

Following firing #8, the battery voltage fluctuated erratically between -175 and -200 Vdc with periodic drops as low as -30 Vdc – where it eventually stabilized, as shown in Figure 5. This behavior lasted approximately 24 hours until the battery sub-assembly on panel #1 had a catastrophic failure as a result of a short circuit. As the energy in the cell was discharging internally through the short circuit, there was a dramatic increase in the battery temperature and pressure as hydrogen gas was being generated from electrolyte decomposition. This process continued until there was a breach of the battery case and a release of this super-heated gas internal to the ESEX flight unit on 22 Apr 99 at 1501 Z. This gas release was likely directed at panel #3, since a 40 °F increase in temperature on this panel was observed over the course of a few seconds. This gas was eventually vented into space, causing a dramatic attitude disturbance

on the vehicle just prior to an umbra crossing. The disturbance was violent enough to saturate the ARGOS reaction wheels and cause the vehicle to spin about the yaw axis at 1/8 rpm through the following eclipse period. This spin resulted in the vehicle automatically switching to a safe mode known as "sunsafe" which sheds non-essential power loads and points the solar arrays at the sun to maximize chances of survival. Once ARGOS exited eclipse, the vehicle was recovered through normal recovery procedures, and no long-term impacts have been observed.
